# Red Hook Small Business Hazard Mitigation Case Studies

## Methodology

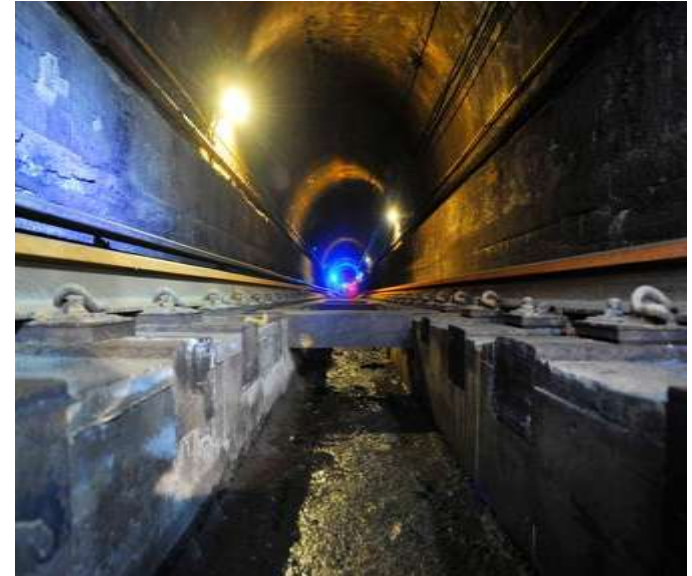
Super storm Sandy flood water receding from MTA R line tunnel

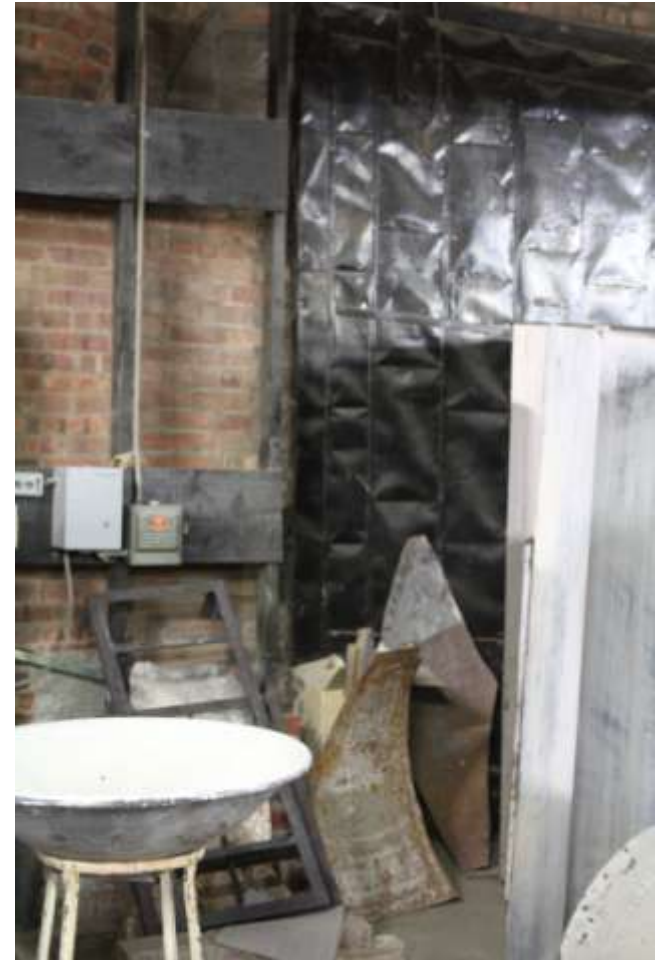
- Located on Upper New York Bay
  - Near Buttermilk Channel
- Base Flood Elevation = +12 ft\*
  - Existing ground elev. +7 ft.
- Front door and rear doors and windows are not water-tight
- Industrial hanging doors between spaces increase risk

Connecting door between leased units allows water to enter Flickinger production area.

- Elevate critical equipment such as kiln motors and polishing equipment
- Seal interior pass doors
- Scan and archive key customer designs using secure off-site provider

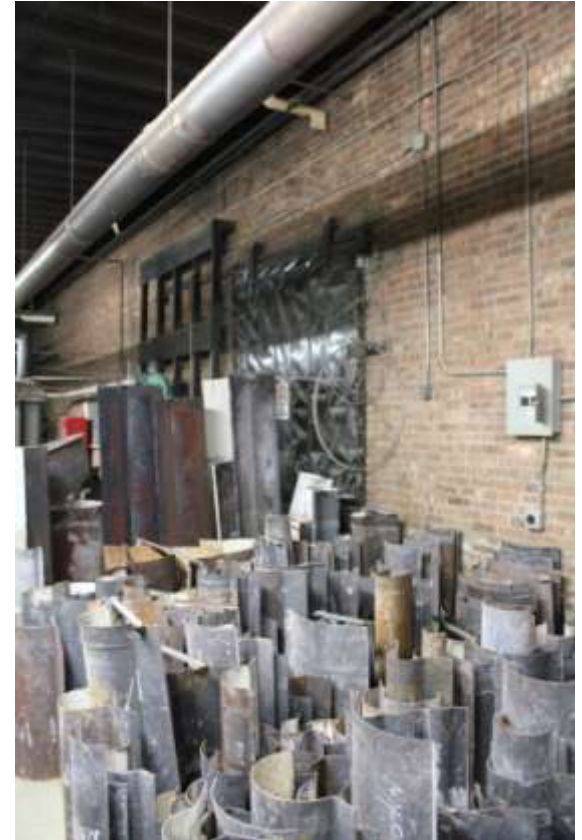
- Flood depth of about 3 ft.
- Business off-line for 4 - 6 weeks
- Operating equipment motors destroyed
- Business records destroyed
  - Off-site back-up storage also destroyed
- Brackish water contaminated kiln lining brick

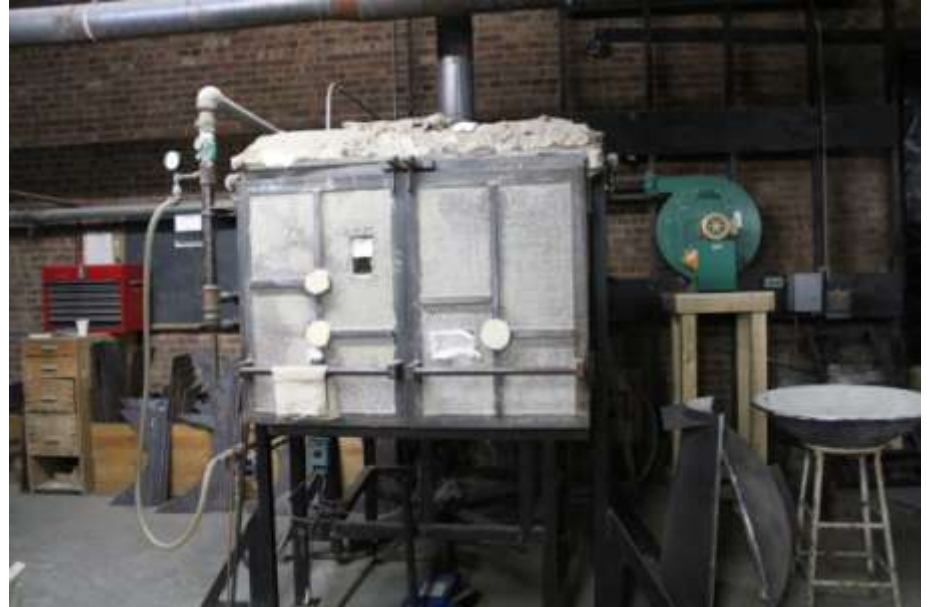
Five at-risk custom kilns; this one features newly elevated electrical engine to the left of the kiln.

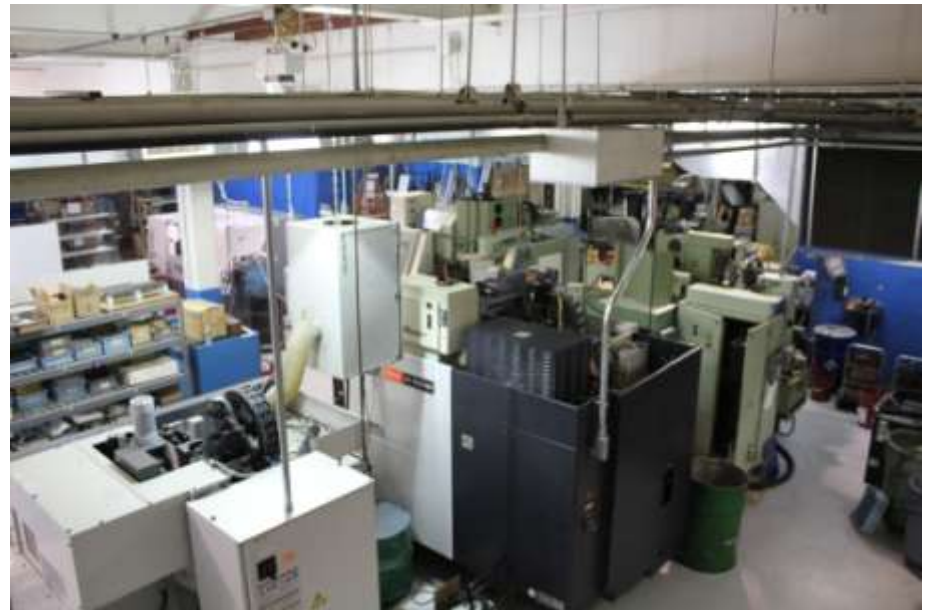
- Business is a few blocks inland from the Upper New York Bay and Erie Basin; Base Flood Elevation = 12 ft.\*
  - Existing ground elevation = + 6 ft.
- Two pedestrian doors and one overhead door
- Plant floor is 3.5 ft. above street level
  - Office space located on mezzanine level

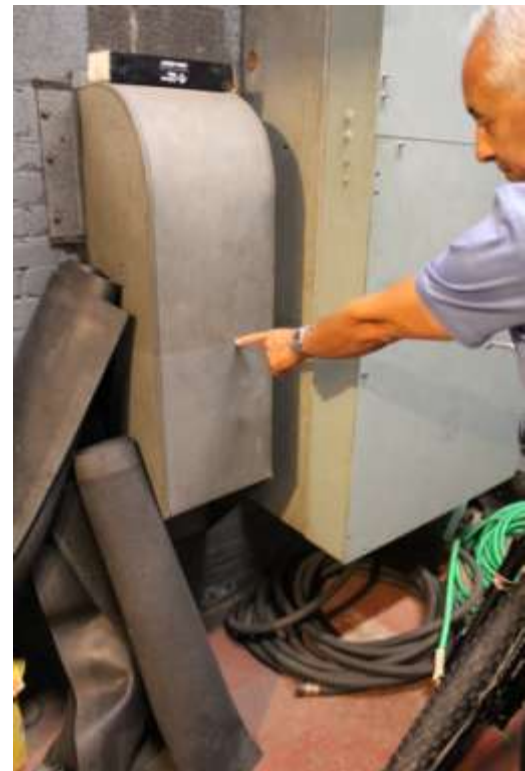
- Flood depth of 3 ft. in loading dock bay
- Sewer line back flow contaminated mechanical room and locker/restroom area
- Eleven months later still working to fulfill backlog orders

High water mark in  
mechanical/electrical switchgear  
room

- Install backflow preventer valve
- Install watertight pedestrian doors
- Reorganize plant floor storage to elevate sensitive items

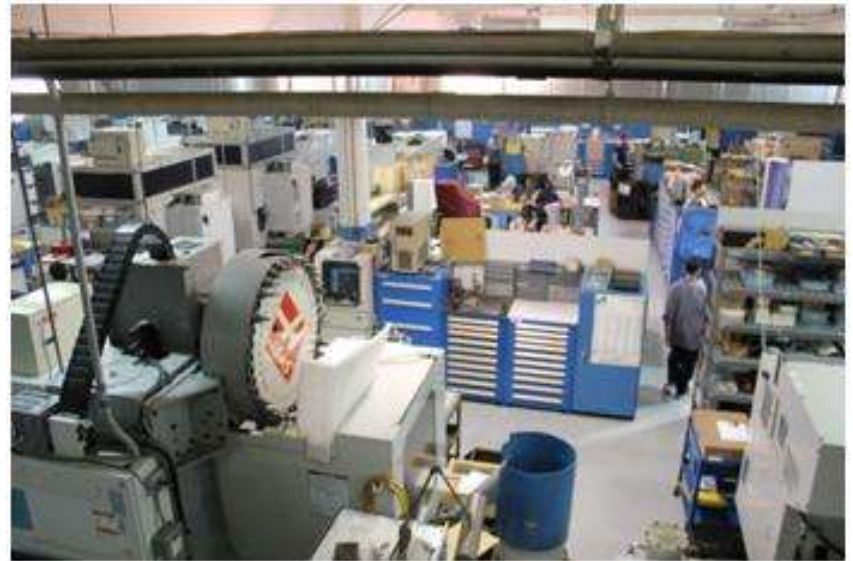
- Prevent flood water from reaching production equipment
- Potential flood water damage to small tools and delicate measuring equipment
- Potential health hazards from sewer backflow
- Temperature and humidity control
- Staff availability via public transportation

Linda Tool production floor

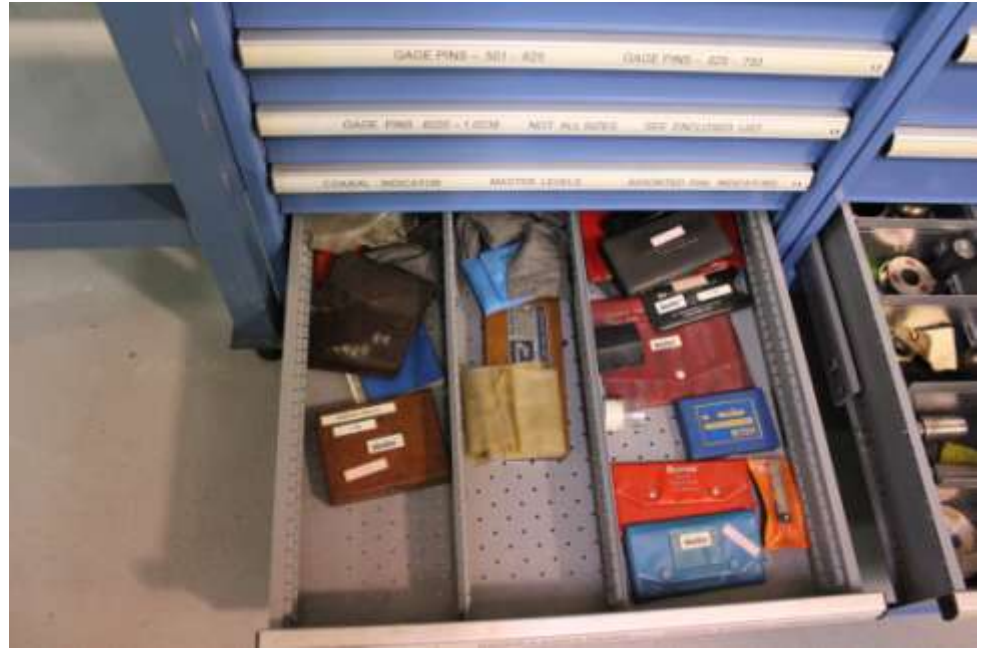
Small tools and measuring equipment  
Stored at floor level

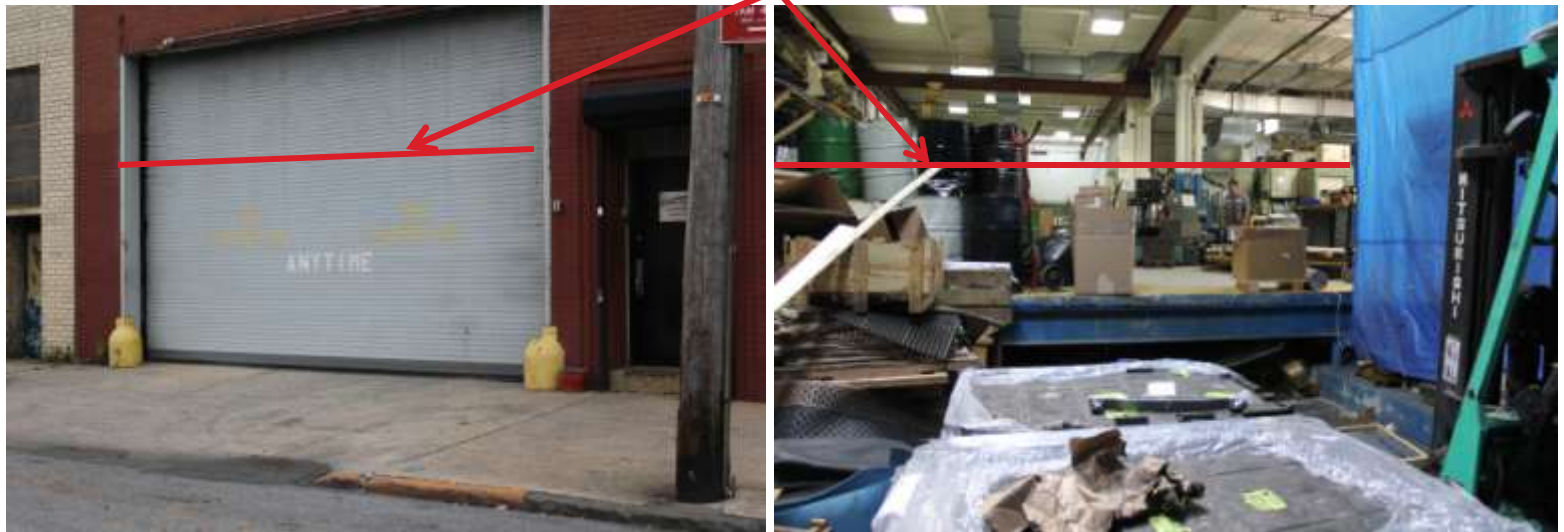
Approximate top of temporary  
Flood Barrier

- Install temporary flood barrier at loading bay door
- Install temporary flood barrier on plant floor around the loading bay
- Institute emergency communications programs

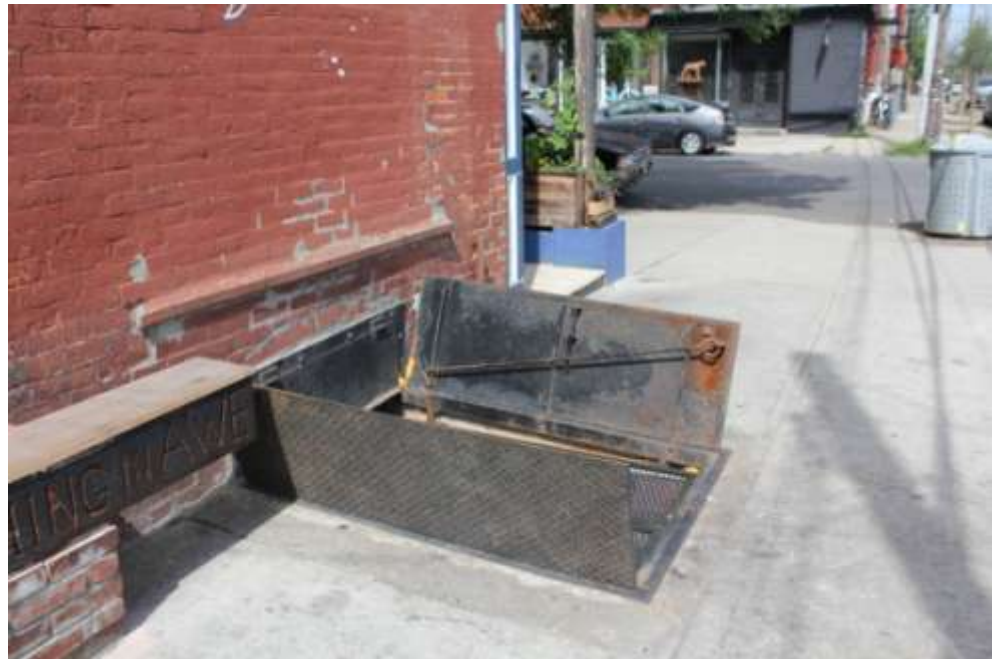
- Basement flooding
  - Through sidewalk entry
  - Through basement wall masonry
- Water damage to ground floor
  - Water rising from basement
  - Seepage through door

Sidewalk hatch door to basement

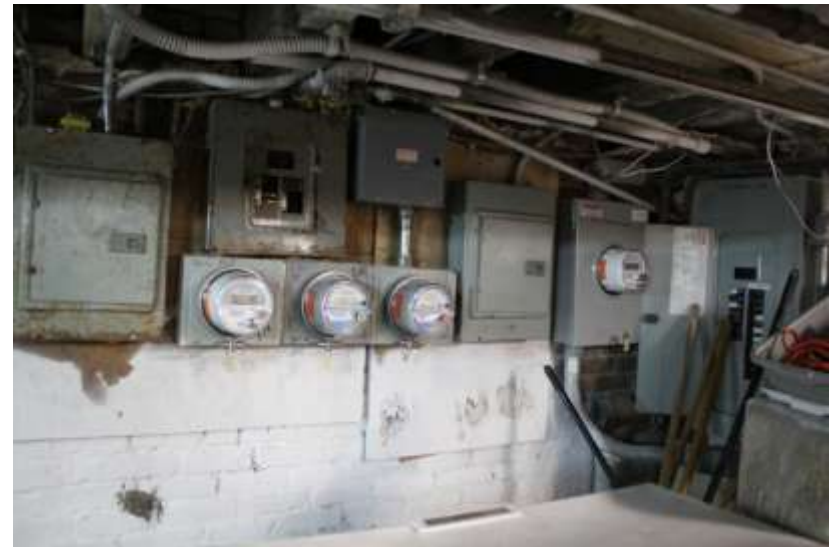
- Basement flooding damaged critical equipment and inventory
- Ground floor flooding damaged equipment, furnishings and fixtures
- Power failure caused loss of refrigerated food
- Electric meters for other tenants also located in basement

Electric service entrance in basement  
Meters for Fort Defiance Café and 2<sup>nd</sup> and 3<sup>rd</sup>  
floor tenants

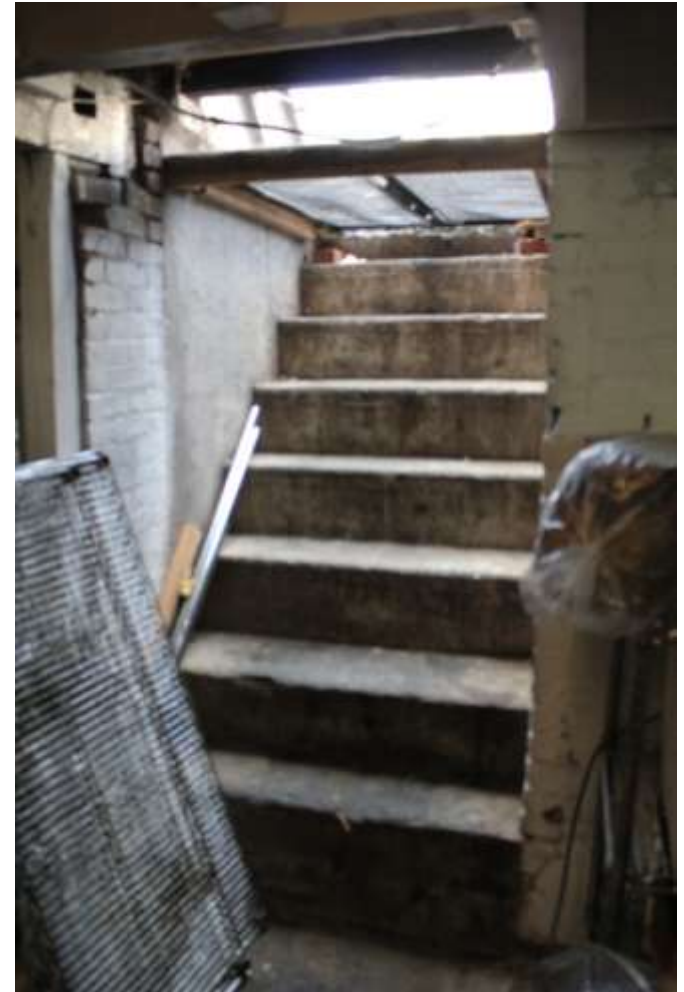
Stairway from sidewalk hatch to basement

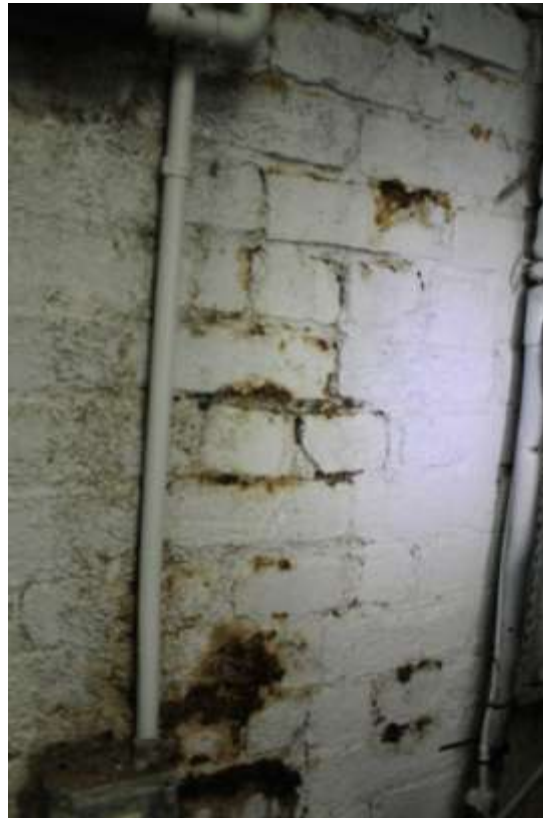
Ft. Defiance basement masonry wall

- Clean and repoint masonry walls
- Install flood door at front entry

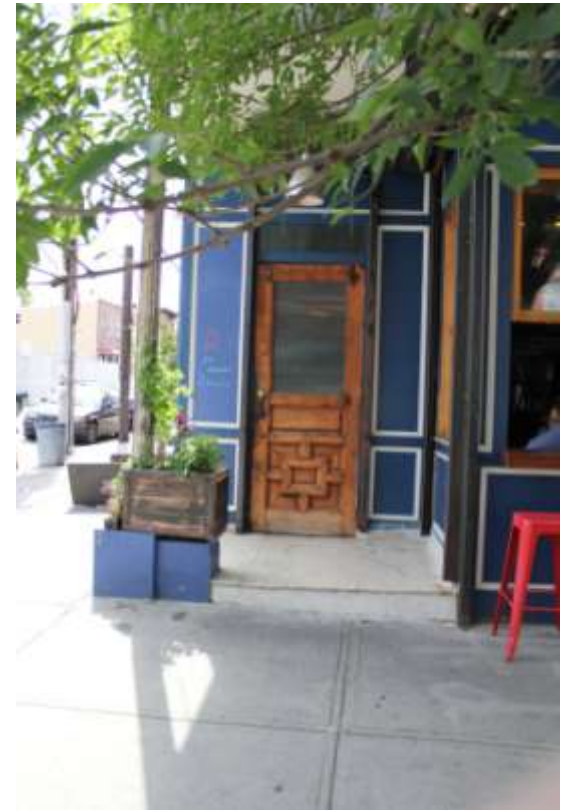
F. Defiance front entry door

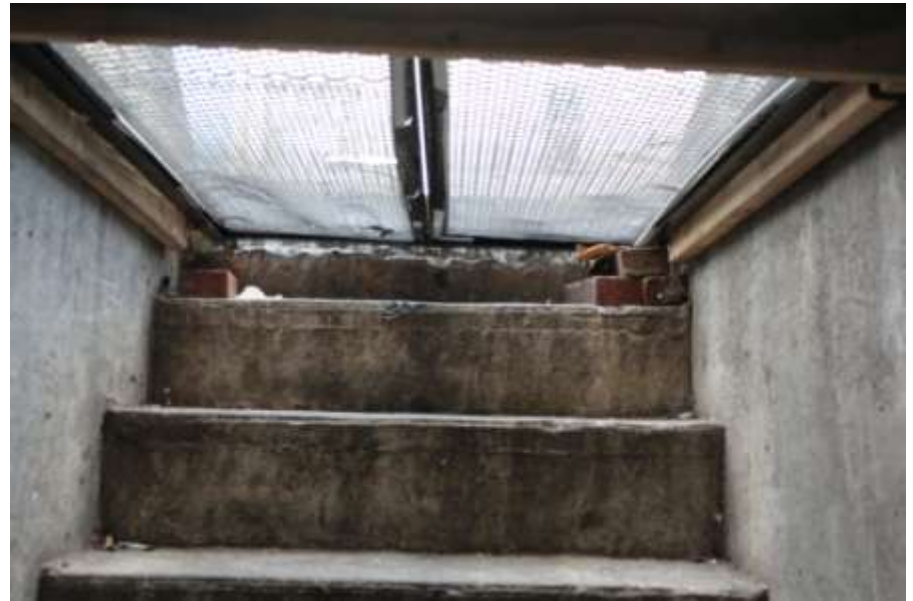
Temporary mitigation opportunity: fabricate temporary flood barrier to fit hatch frame. Install barrier and seal joints with spray foam.

- Temporary flood barriers at openings
- Conduct plumbing survey and seal unused drains
- Disconnect and relocate critical equipment
- Evacuate critical supplies and inventory prior to severe storm event

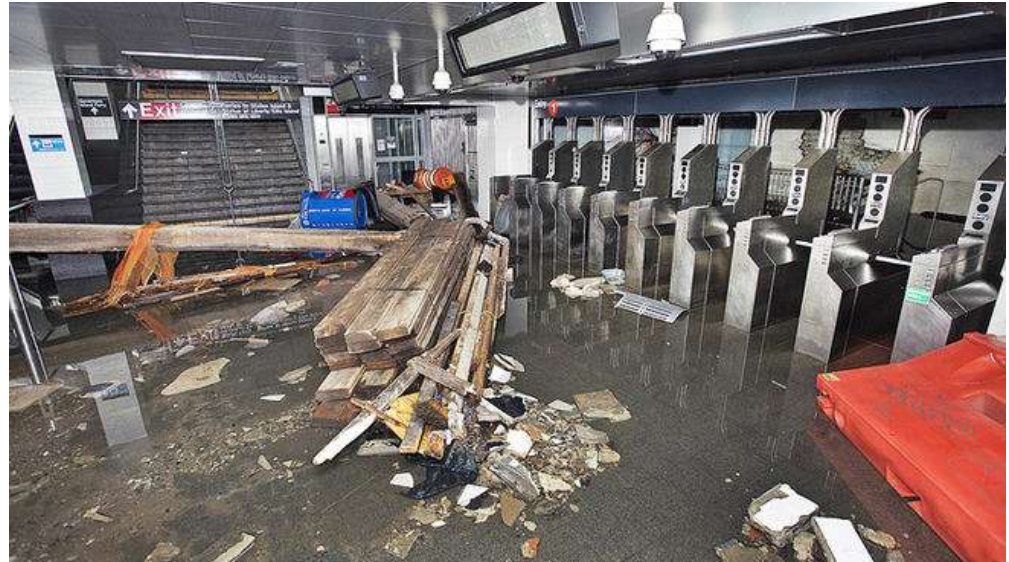
Post Sandy flooding of MTA subway station
